## **2011 Operations, Maintenance, and Monitoring Report**

### **PERRY RIDGE SHORE PROTECTION**

State Project Number CS-24  
Priority Project List 4

June 2011  
Calcasieu Parish

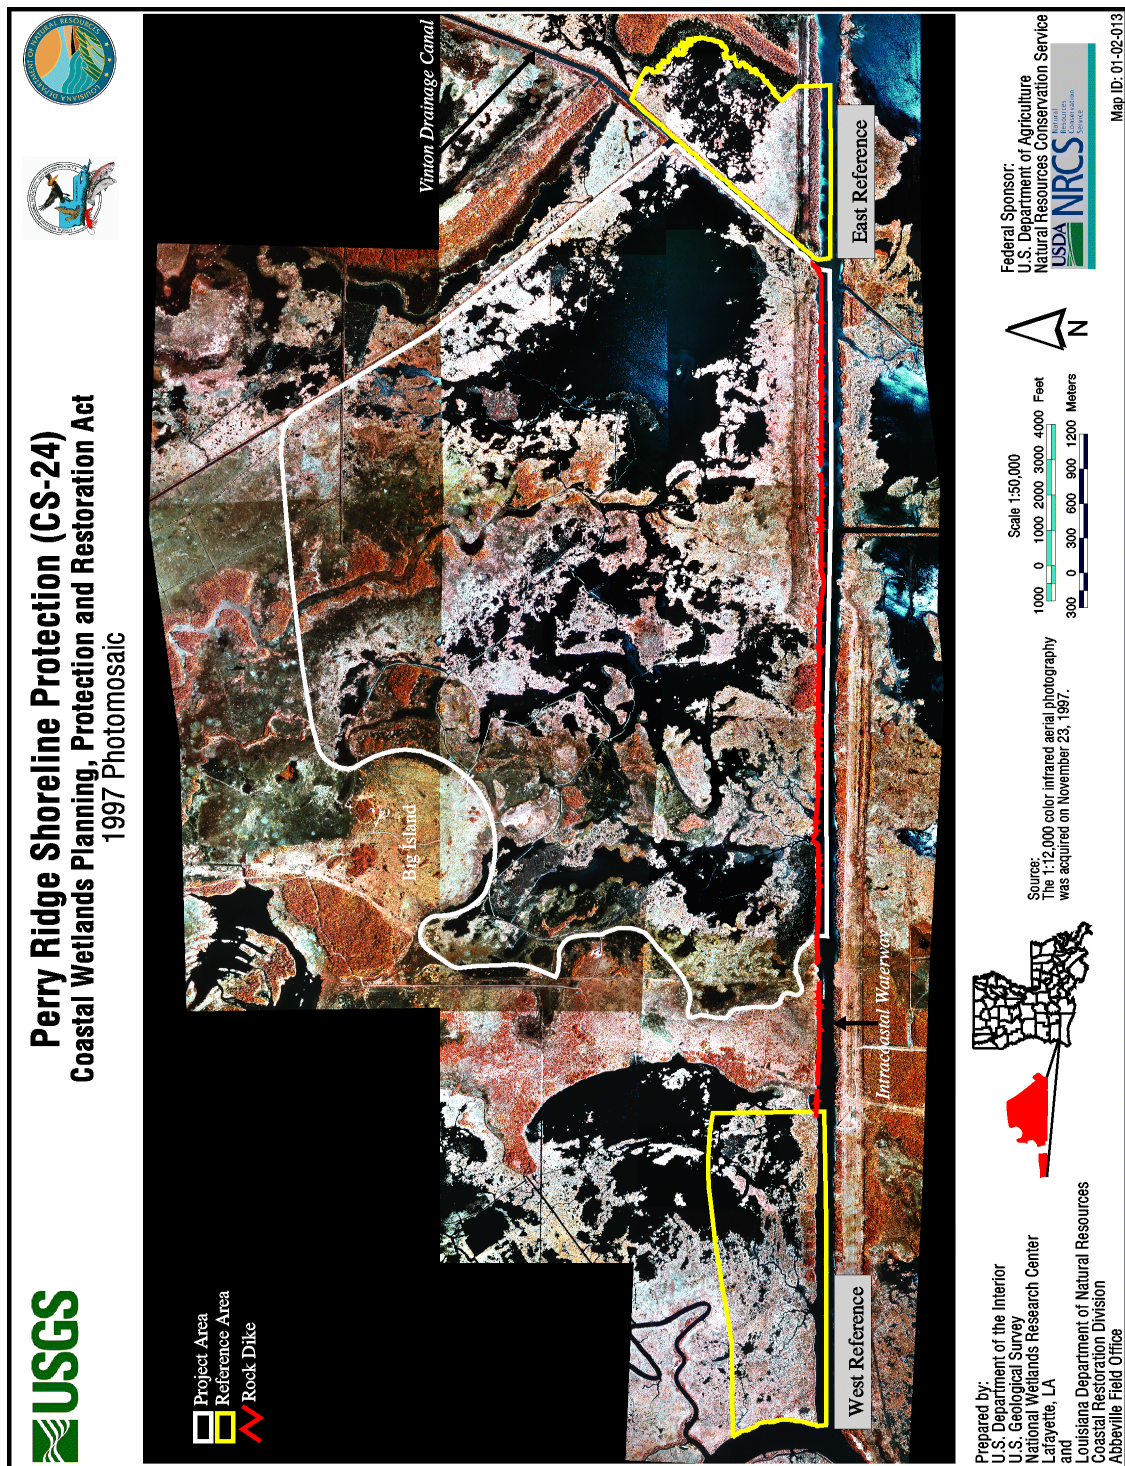
**Figure 2.** Photomosaic of the Perry Ridge Shore Protection (CS-24) project and reference areas from aerial photography flown November 23, 1997

Pre-construction photography, flown on November 23, 1997, indicated that the project area was 60.4% land and 39.6% water (Figures 2 and 3). Aerial photography flown on November 17, 2001 documented 65.4% land and 34.6% water in the project area, indicating a land gain of 5% or 306.5 ac (124.0 ha). The higher land to water ratio indicates expansion of the interior marsh behind the protected shoreline. In areas without shoreline protection, the western reference area remained 58.8% land and 41.2% water, and the eastern reference area made a slight gain from 61.4% land and 38.6% water in 1997 to 62.7% land and 37.3% in 2001.

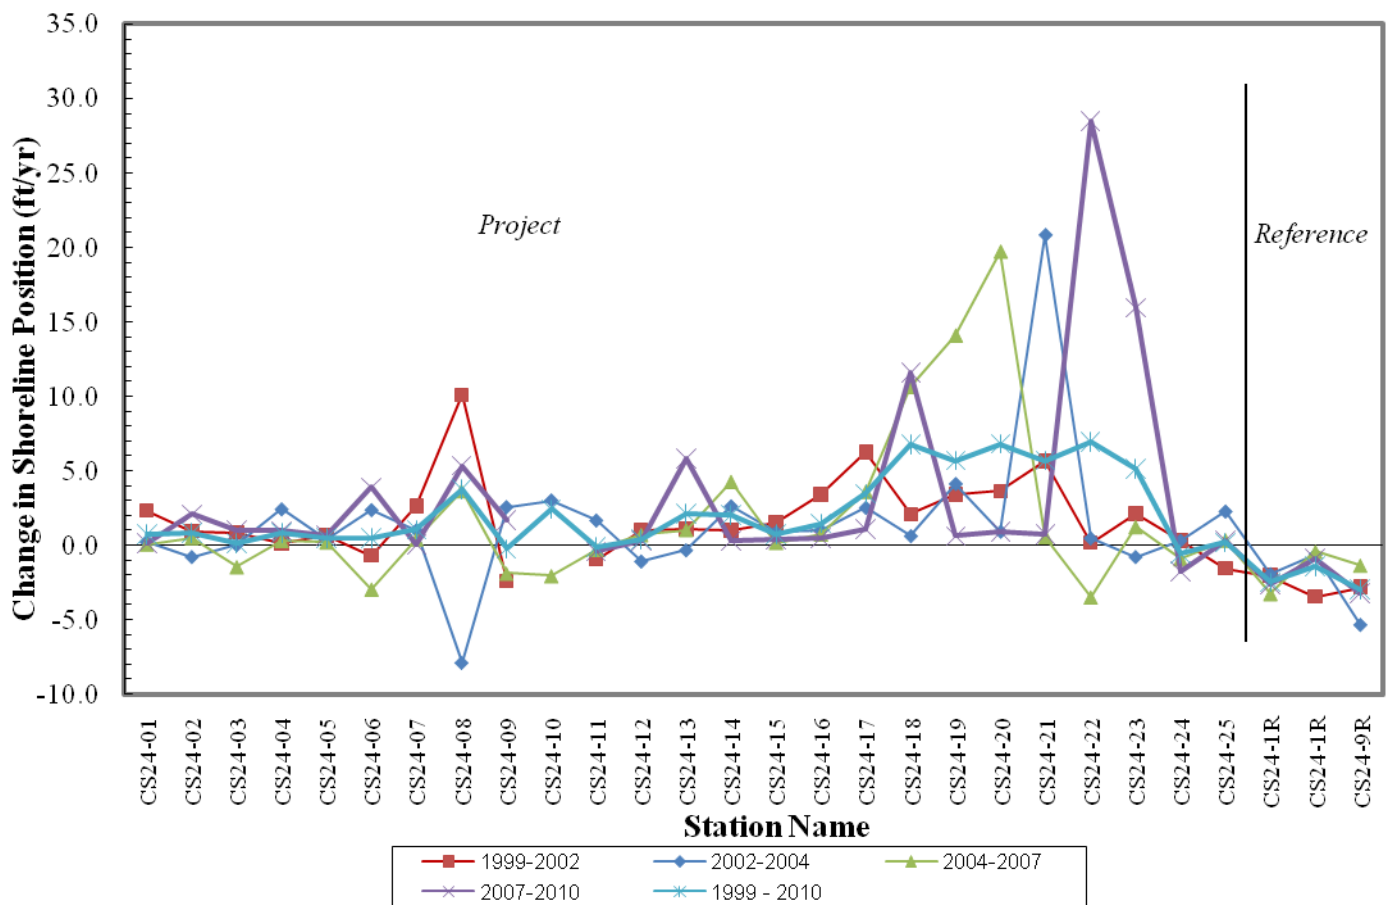
**Figure 5.** Shoreline position change (ft/yr) from direct measurements in the Perry Ridge (CS-24) project area from 1999-2010.

Average shoreline rates across all surveys in the project and reference areas are presented in Table 1. The 2010 data indicate that 23 of 25 monitoring stations along the shoreline in the project area are prograding while the shoreline position at all reference sites continues to retreat (Figure 5). These data also indicated a substantially larger progradation rate than other years. This could have been due in part to deposition from Hurricane Ike. The largest areas of gain occurred at stations 22 and 23 on the east side of the project area. These were previously open water areas in 2007 that were colonized by *Typha latifolia* and *Spartina alterniflora* by 2010.

The 2010 shoreline survey indicates the project has been effective at preventing shoreline erosion. The average rate of gain over all 25 project stations was 3.4 ft/yr (1.04 m/yr) while the shoreline in the reference area stations continued to retreat at a rate of -2.2 ft/yr (-0.67 m/yr). Visual observation indicates vertical accretion of the wetland area at 23 of 25 monitoring stations between the foreshore rock dike and the shoreline. The next shoreline marker survey is scheduled for the summer of 2013. The structural components of the Perry Ridge Shoreline Protection Project are in good condition and functioning as designed.

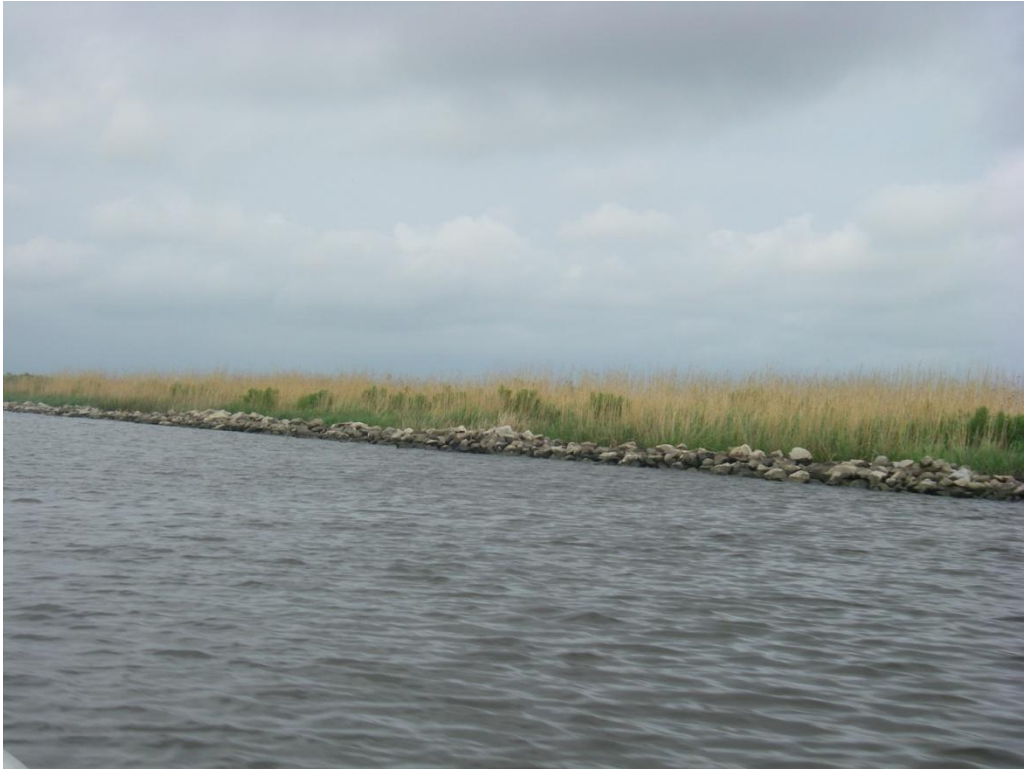
**Photo No.1, Typical rock dike**

The dike is in excellent condition with some very small areas being below constructed elevation. Visible signs of accretion are occurring behind the rock dike in some areas. No maintenance is recommended at this time. (Photos: Appendix A, Photo 1)

Item	Condition	Physical Damage	Corrosion	Photo #	Observations and Remarks
Steel Bulkhead / Caps	N/A				
Steel Grating	N/A				
Stop Logs	N/A				
Hardware	N/A				
Timber Piles	N/A				
Timber Wales	N/A				
Galv. Pile Caps	N/A				
Cables	N/A				
Signage /Supports	N/A				
Rip Rap (fill) (foreshore dike)	Good			1	Accretion occurring behind rock dike.
Earthen Embankment	N/A
